Human Environment and Transport
Inspectorate
*Ministry of Infrastructure and the
Environment*

Fatal accident on board a Dutch freezer-trawler 7 September 2011

7 September 2011

Date 28/02/12
Status Final version

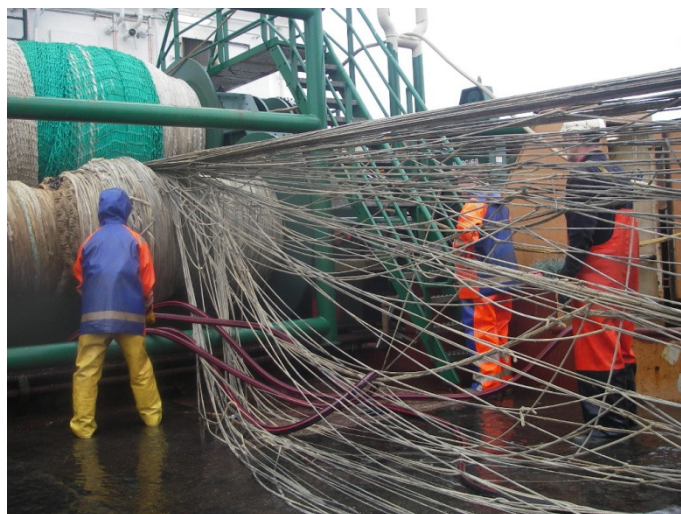
One of the Russian sailors untangled the hose and, while doing so, was standing in the net that was lying on the deck. The boatswain then made a hand signal to the bridge, which was interpreted as 'haul in'. The captain subsequently switched on the winch to continue hauling in the net. It later turned out that the hose had not yet been removed from the net and that the boatswain had given the 'let out' signal. Therefore the sailor was still standing near the winch, ready to remove the rest of the hose. Due to the hauling, the sailor, who was busy with the hose, became trapped between the net and the winch.

Figure 1: Reconstruction of the situation prior to the accident (photo taken by crew)

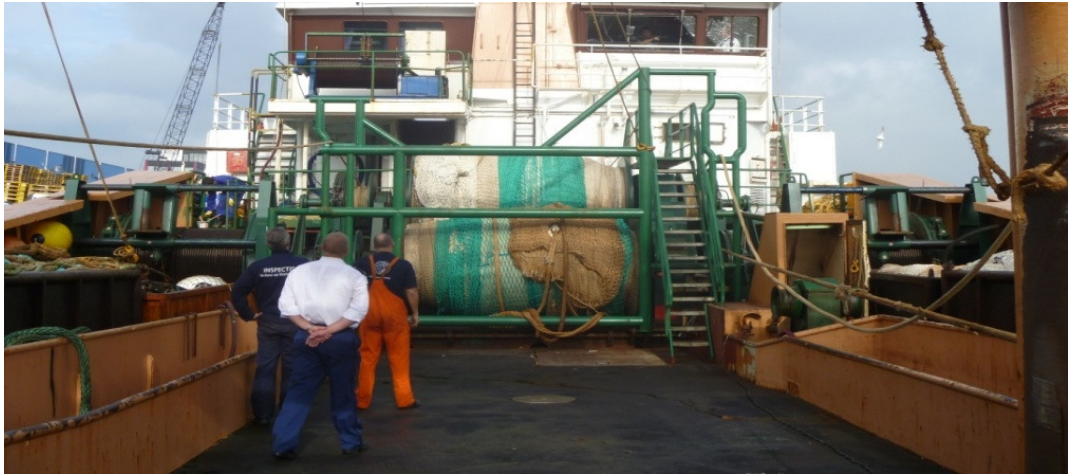
In this case, one of the hoses had rolled out over the middle deck from a deck wash hydrant near the winch. As a result, the hose was wound onto the roll with the net when the net was hauled in. According to the crew, the hose is not allowed to be there when the net is hauled in.

Figure 2: Aftdeck, place of the accident

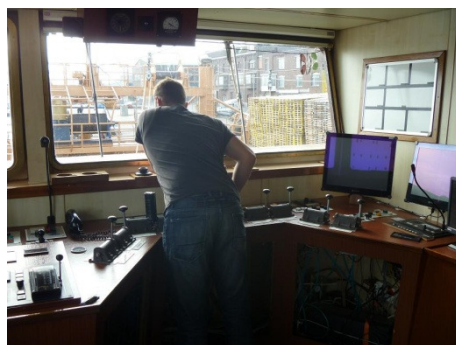
Figure 3: Control console

The control console is located at the back of the wheelhouse on the starboard side. From here, the person at the console has a good overview of the aftdeck including the winch and the net drums. A number of blind spots on deck where work sometimes has to be carried out are provided with cameras (near the stern gantry). The monitors for these cameras are located beside the console.

A standard feature of Dutch stern trawlers is that they are equipped with the winch console at the back of the wheelhouse. Beside the control console for the winch is a manoeuvring console. Depending on the ship's movements, it may be necessary to perform manoeuvres while working with the winch. The idea behind having the consoles located side by side is that the captain retains a full overview and is able to manoeuvre or operate the winch at the same time.

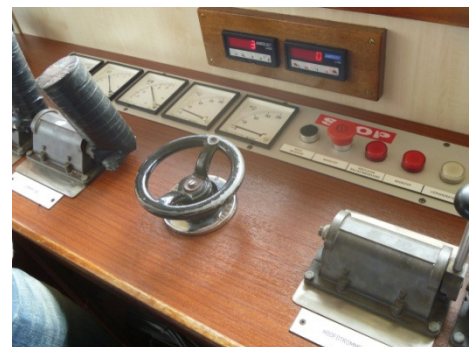
Figure 4: Control wheel

There are selectors (levers) for the different drums and a control wheel to operate the winch. The control wheel can be turned in small steps, with different positions corresponding to different speeds. The wheel is turned to the left to let out the net, and to the right to haul in the net.

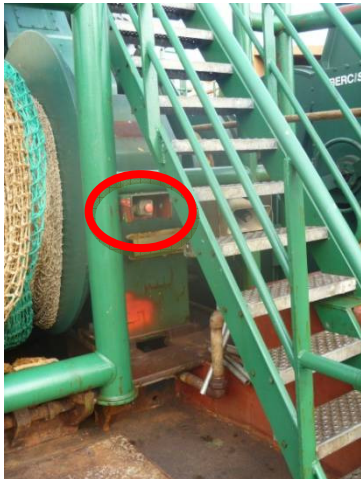
Figure 5: Emergency stop of the winch behind the stairs

As luck would have it, the boatswain was standing close to an emergency stop, precisely the emergency stop that was installed in a rather inconvenient place, namely under the stairs. It all happened very quickly, so it is unlikely that activating this emergency stop could have prevented it unless someone already had his hand near the stop. This indicates that an emergency stop is only of relative use in preventing sudden incidents.

The Inspectorate sees possibilities for enabling the winch to be operated more safely. A dual control could be a solution to such risks. This could concern a main control in the wheelhouse and an activation unit on deck. The winch is only released by the manager on deck when it is safe. Only then can the winch be operated from the console. This prevents the unfortunate consequences of incorrect interpretation of communication. This way the winch can be stopped from the deck in dangerous situations, without having to walk to a fixed emergency stop first. An appropriate recommendation will follow.

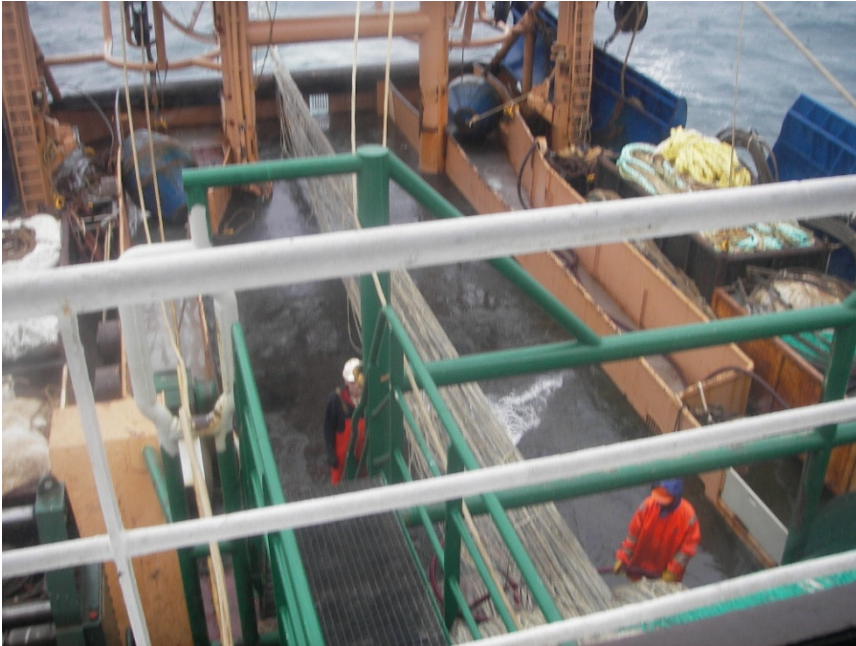
All in all, a reasonably good overview is possible from the control position, but this gives the false appearance that a good overview of the details is also possible. In any case, this accident shows that the view from the control console is not sufficient. The photographs below taken by the crew members confirm this. The captain must always call on the people on deck for a good overview of the details. The work must be properly supervised there. The captain must be able to rely on this, and only perform operations with the winch in accordance with the corresponding and agreed signals.

Figure 6: Visible details from console. Boatswain is partly visible; sailor is in view.

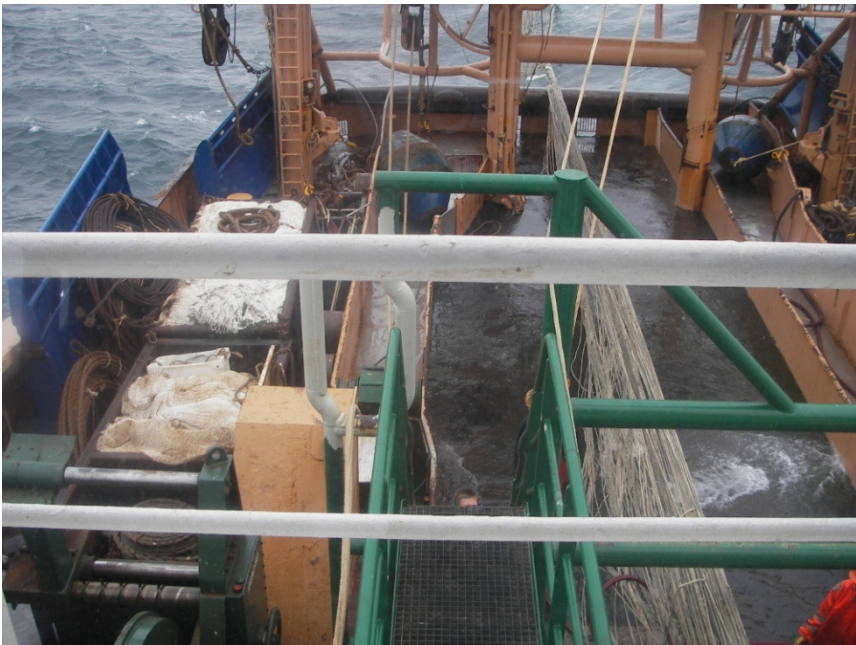
Figure 7: Visible details from console. Boatswain is not visible.

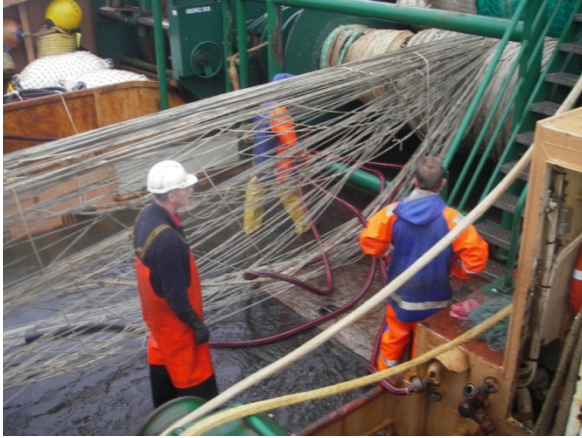
The investigation revealed that there is a separation of duties among the personnel on the aftdeck. Although not laid down in writing, it is generally assumed that the boatswain is in charge and supervising. Responsibilities have not been laid down. The captain actually did not have a clear enough view of the boatswain. And it is not clear whether the boatswain had a sufficient view of the situation on deck at that time. In that case he could have seen that a sailor was standing in the net and the only correct instruction should have been: "stop!"

Figure 8: Simulation of the situation prior to the accident. The boatswain (left) was unable to see clearly that the victim (centre) was standing in the net.

The lack of supervision / management on the afterdeck, or the execution thereof, has come up several times in investigations (see Appendix 6). The same findings were revealed during this investigation, with regard to the failure to remove the hose as well as failing to see the sailor standing in the net. Furthermore, it was revealed that the shipping company could play a more active role in increasing quality awareness and supervision. Actively instructing managers to do so could contribute significantly to the prevention of accidents. An appropriate recommendation will follow.
