# Joint Network Secretariat

## Normal Procedure Task Force

### Broken wheels

### Final output

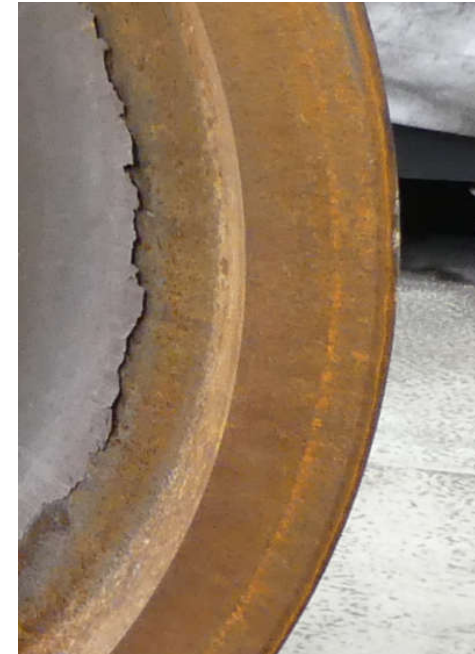
- Test with wheel accordance UIC 510-5 or metal plate heating up in furnace or burner
- Boundary conditions, like roughness and treatment of the wheel and thickness of the paint
- if needed: heating up ramp necessary (e.g. 15 min 200°, 15 min 250°, 15 min 300° with each 5 min heating up time)

Paint shall be clearly burnt => paint in this area shall present cracks/ peeling / bubbles (no direct dispersion)

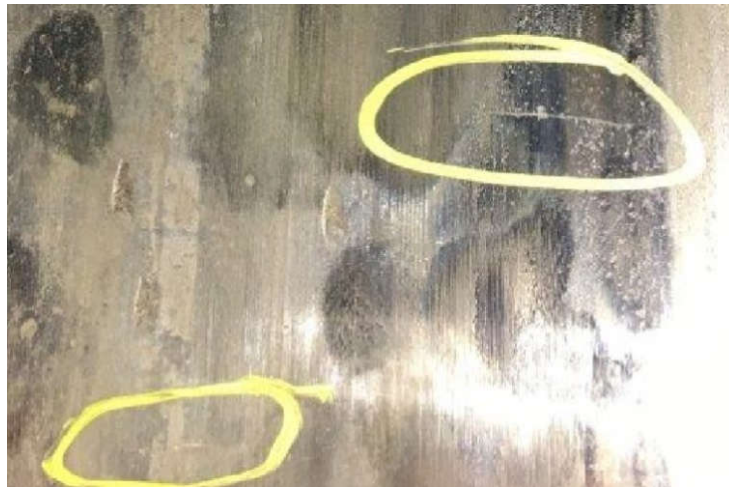
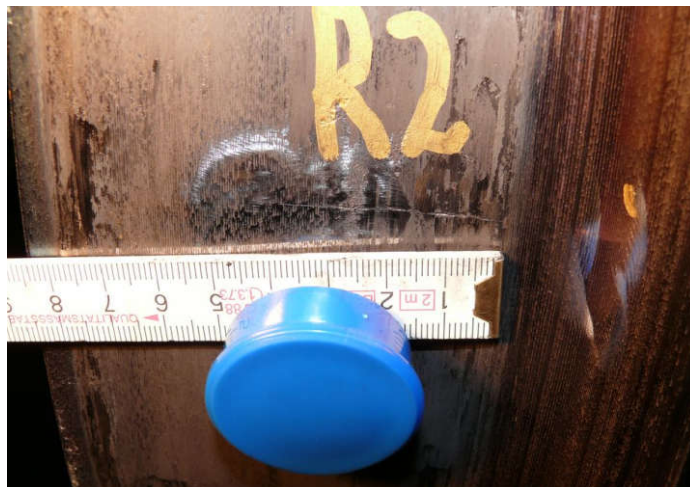
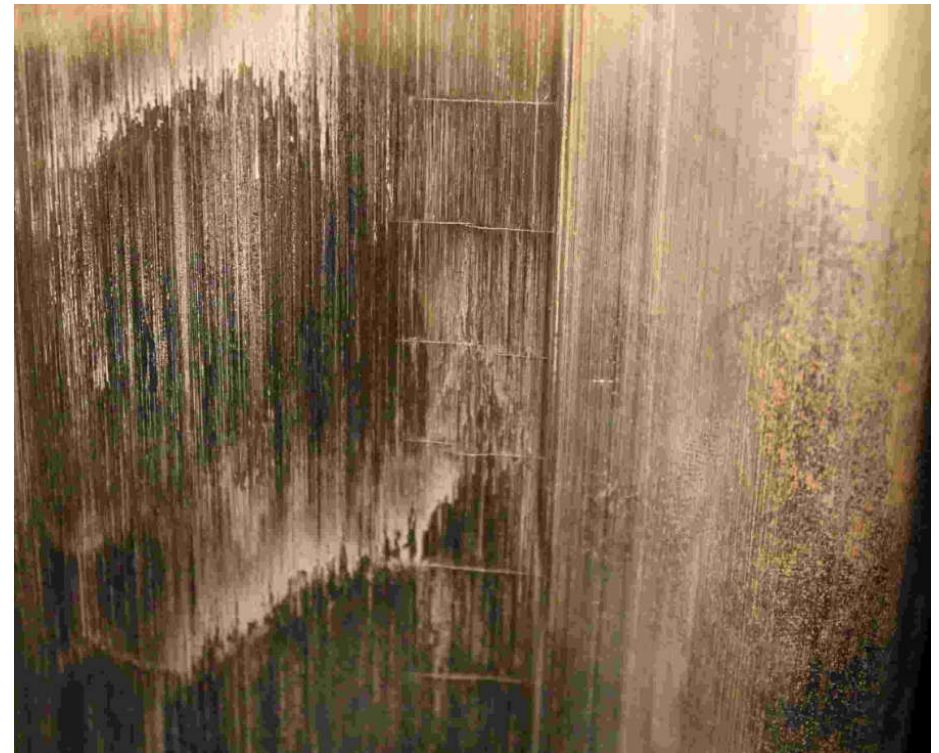
Example for single cracks on the wheel tread by visual inspection

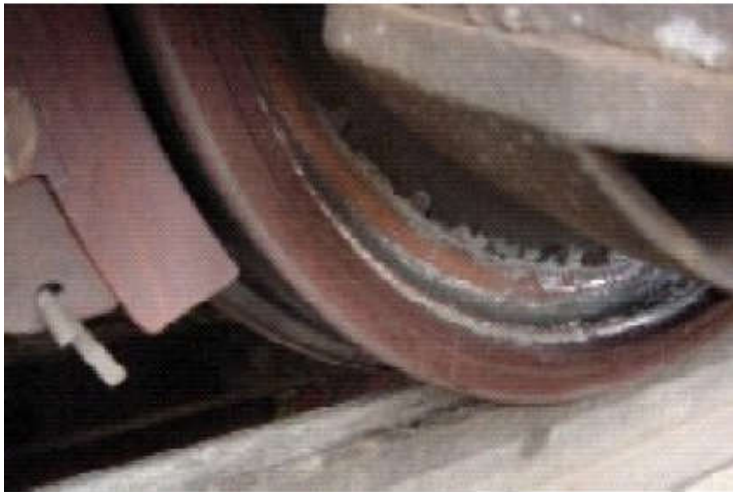
**Description:** This type of defect occurs only in tread-braked wheels. When suitable coatings are used, the paint becomes clearly burnt in the rib/web transition radius when the temperature exceeds approximately 300 °C. The paint in this area then becomes cracked and peeling. The brake blocks are often melted to some extent. Build-up of metal and characteristic colouring can be seen on the tread. The rim may also become a bluish colour.

If the problem is not detected immediately the rim/web transition can gradually assume a rusty appearance with shades between greyish-brown and brown covering the whole circumference. [EN 15313, §C.3.2.2]

Overheating affecting the wheel rim/web transition [EN 15313, §C.3.2.2]

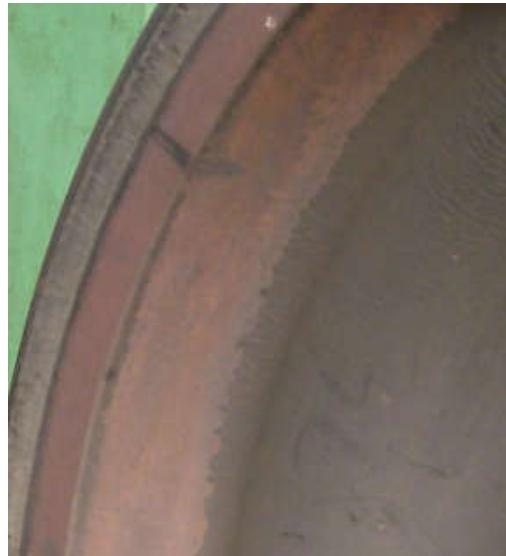
Old and fresh burnt paint

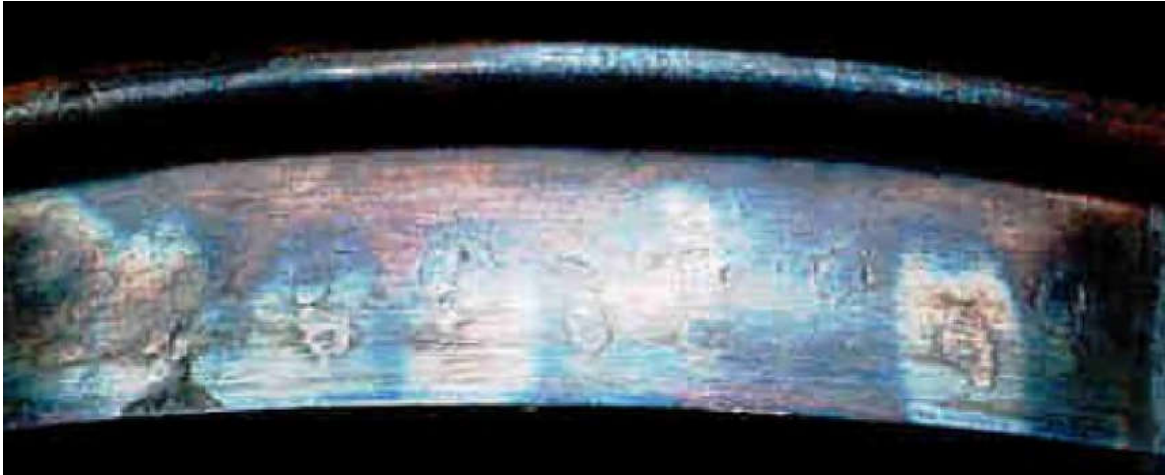
colouring on the tread

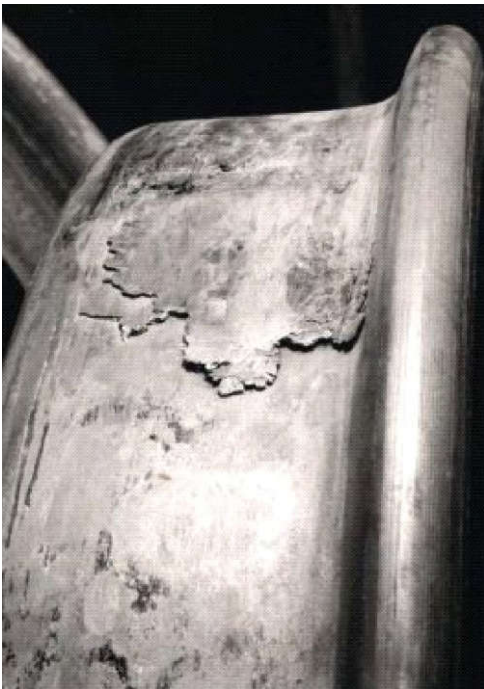
Metal build up on  
the tread

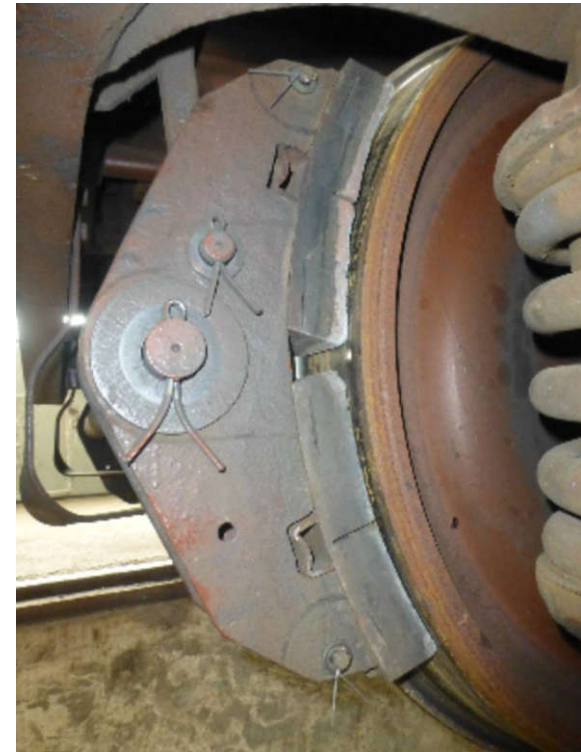
Melted brake block
