# JNS Normal Procedure

## "Accident Gotthard base tunnel - broken wheels"

JNS report | version 5.0

### ECM Working Instruction for the visual inspection of the component tread braked wheel

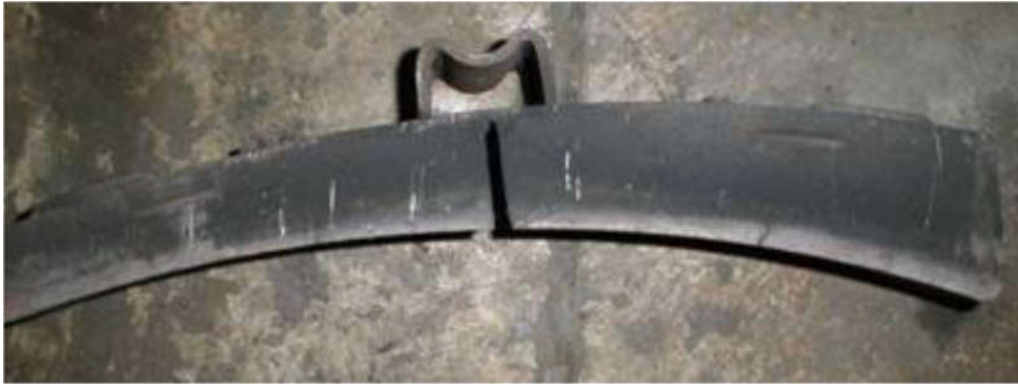
Figure 1: Organic brake blocks: 'White layer' in the rubbing surface near to the surface area, up to 10mm thick, friction carbon deposits [UIC Leaflet e541-4, 3. Edition]

- To fulfil the in-service limit requirement for the mileage interval
- During change of brake blocks in- or outside of workshops (except the rail wheel – contact)
- During axle inspections done in accordance with the European Visual Inspection Catalogue (EVIC) (see EN 15313, chapter 6.5.13.2)
- wagon heavy maintenance (revision)
- During off-vehicle maintenance
- If the ECM during wagon technical inspection gets aware of any indication of thermal overload of the wheel or thermal indications on the brake blocks (see Figure 1 to Figure 4) or after detected fixed brakes

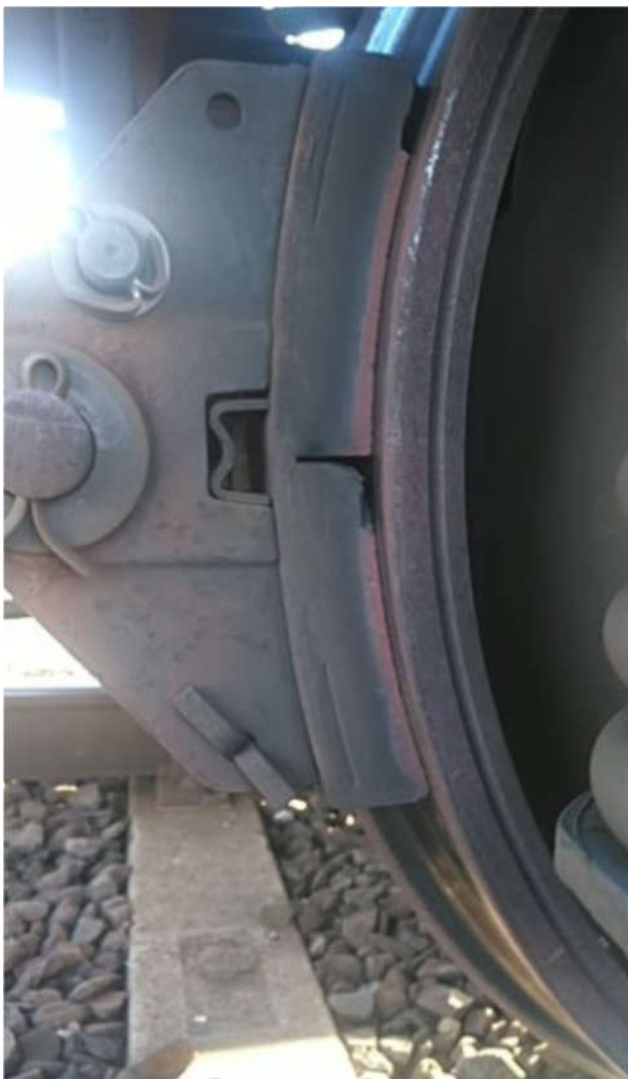
Figure 2: Organic brake blocks: 'Red layer' in the rubbing surface, up to 10mm thick [UIC Leaflet e541-4, 3. Edition]

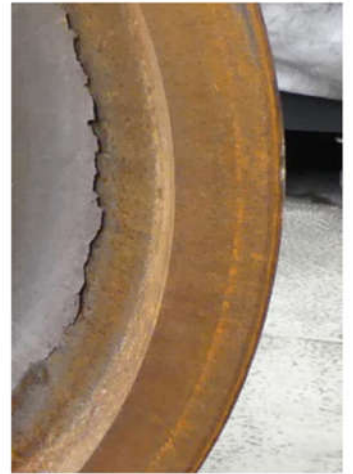
Figure 8: Signs of thermal overload of the wheel – burnt paint

- Figure 8 and discoloration of the tread and metal build-up on the tread – see pictures Figure 9 are not acceptable.

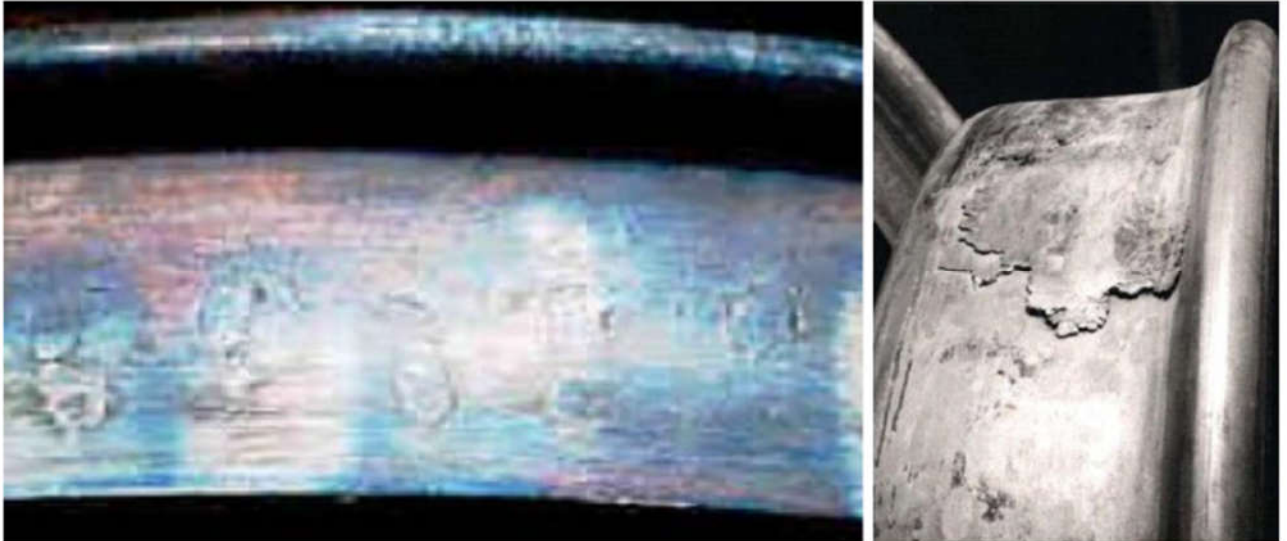
Figure 9: Signs of thermal overload of the wheel - discolouration of the tread and metal build-up on the tread
