# JNS Normal Procedure

## “Accident Gotthard base tunnel - broken wheels”

JNS final report | version 5.0

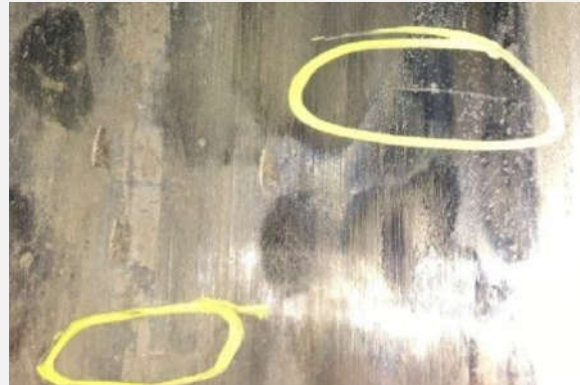
**Description:** The tread exhibits cracks at an angle of approximately  $90^\circ$  to the circumference of the wheel and have a typical length of 30mm or more. Transverse cracks generally develop at the surface in either straight or slightly crooked lines and can penetrate radially (usually of thermal origin in these cases) or branch out in a circumferential direction (usually of mechanical origin in this case). They occur individually and can be distributed at several points around the circumference. [EN 15313, §C.2.6 ]

Transverse crack revealed by magnetic particle testing [EN 15313, §C.2.6 ]

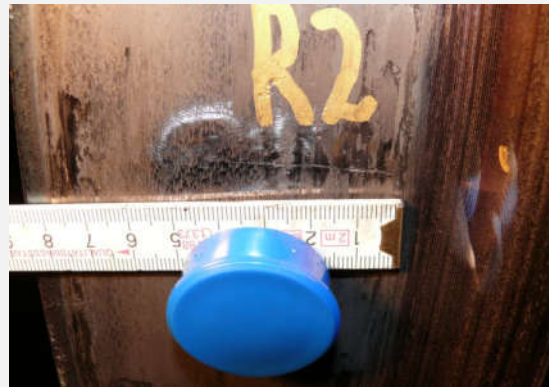
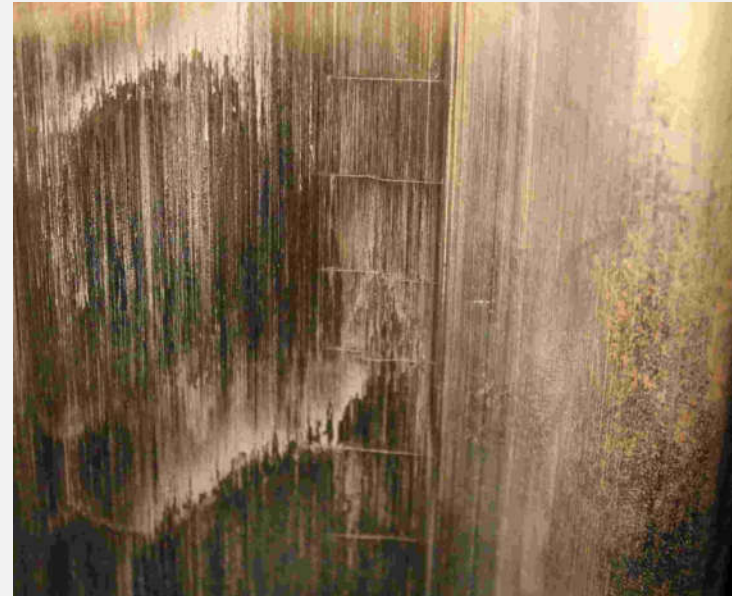
Example for single cracks on the wheel tread by visual inspection

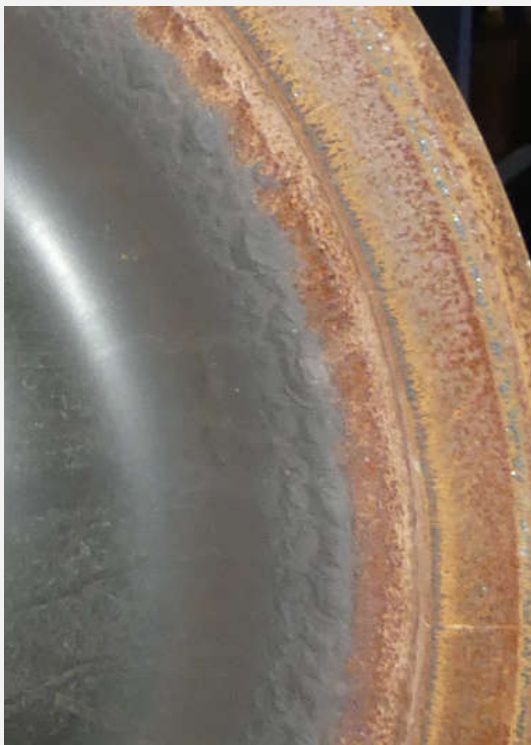
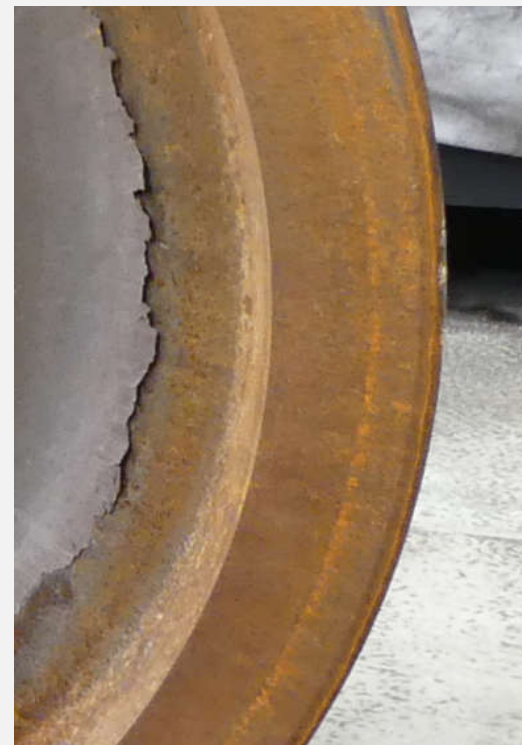
- burnt paint at connection between rim and wheel web;
- traces of rust at connection between rim and wheel web;

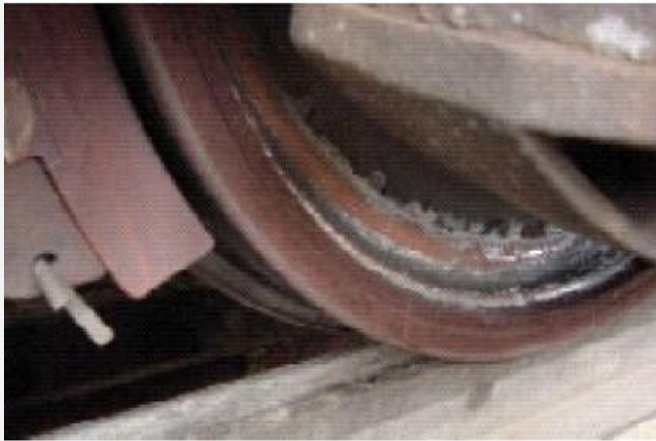
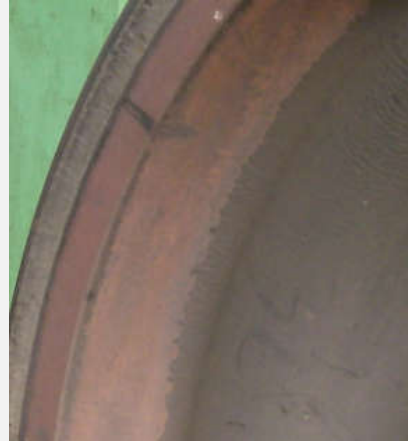
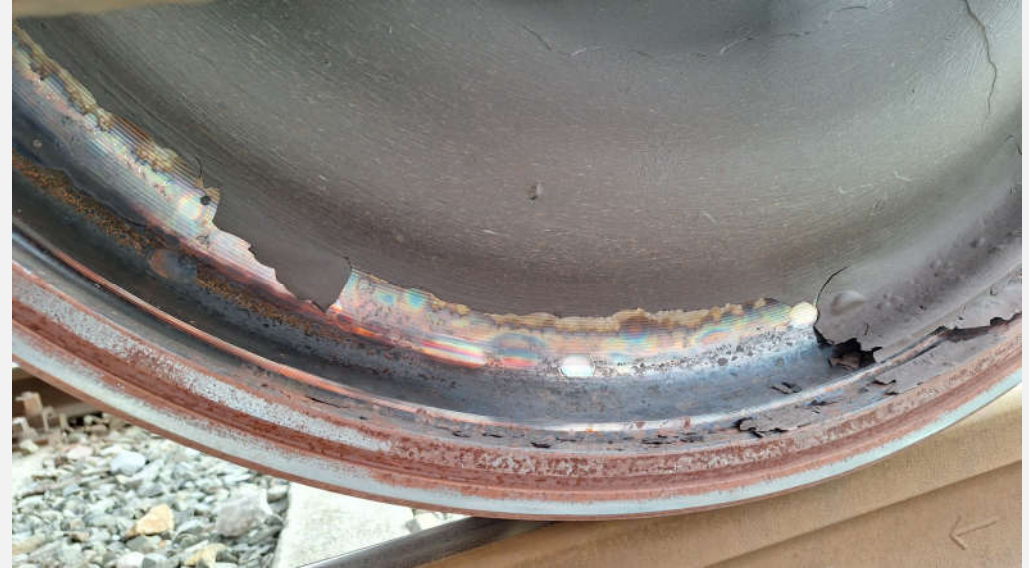
- burnt paint at connection between rim and wheel web;
- traces of rust at connection between rim and wheel web;

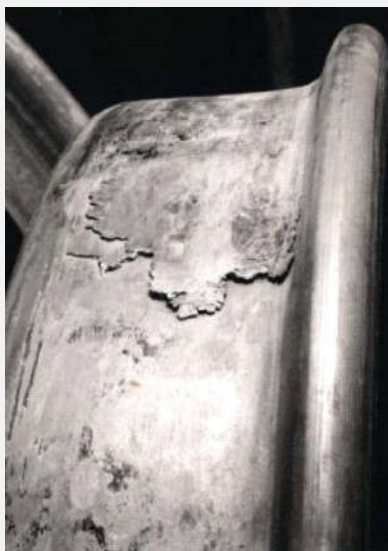
Metal build up on  
the tread

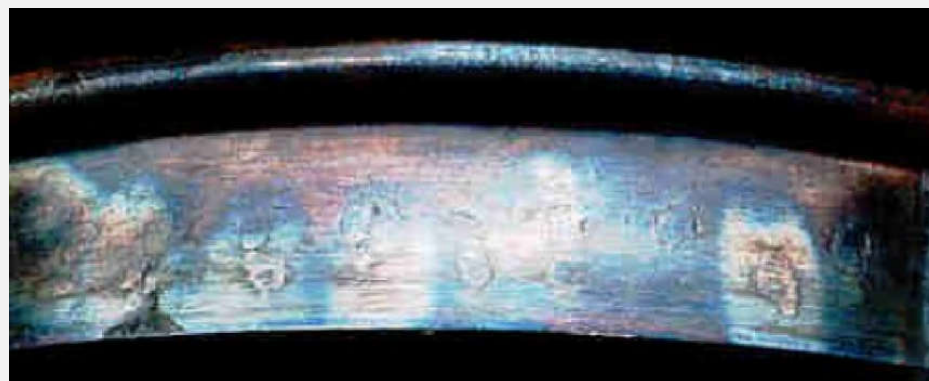
bluish coloured rim from overheating

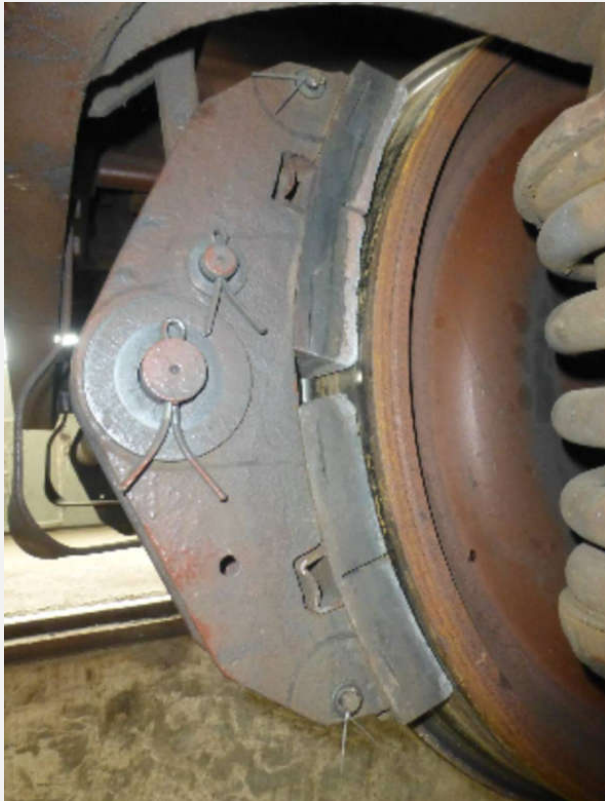
Cast iron brake blocks - Melted brake block

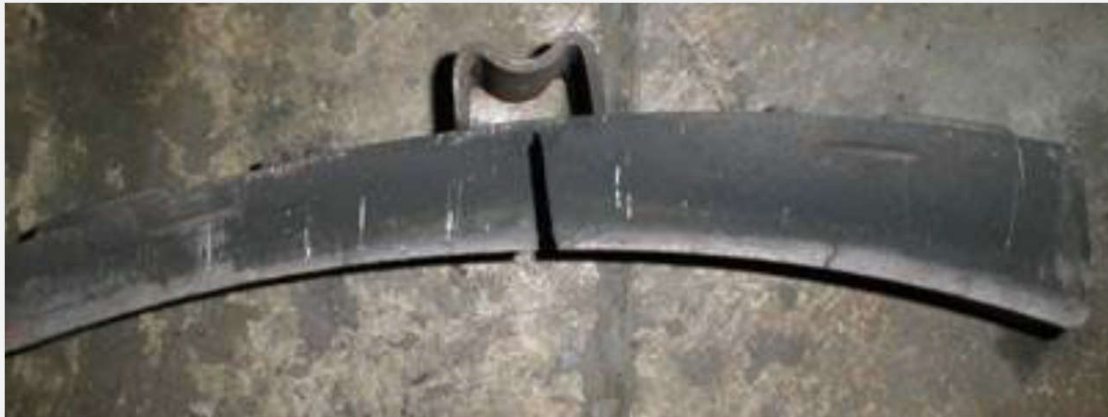
Organic brake blocks: White layer' in the rubbing surface near to the surface area, friction carbon deposits

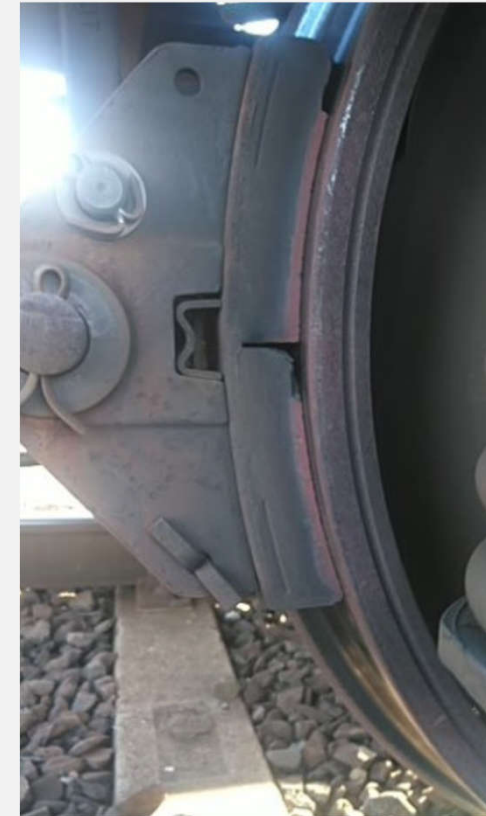
Organic brake blocks: 'Red layer' in the rubbing surface

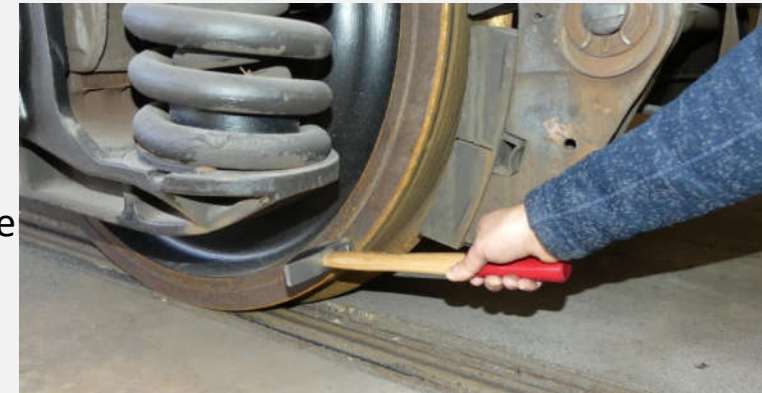
- The hammer (sound) test shall be done by qualified staff;
- The hammer (sound) test shall be done with a metal hammer;
- The hammer (sound) test shall be done with fully released brakes;
- The hammer (sound) test shall be done at the outer side of the rim's circumference in the following areas (see photo) expressed in terms of clock time:
  - between 1 and 5;
  - Between 7 and 11;

- Wheel responds with a thud-like/damped sound: crack from the rim to the web (independently from the position of the cracks over the circumference);  
Important: defects on the tread (without cracks propagated to the web) cannot be detected;
- Wheel responds with a ringing sound: no cracks from rim to web (independently from the wheel type (web shape) and wheel diameter).
